ASBESTOS INSPECTION REPORT – ROOF SURVEY

SAN PASQUAL VALLEY ELEMENTARY SCHOOL BUILDING 102 and Lower Roof, BUILDING 101

May 4, 2023

ENCORP PROJECT NUMBER P23214.RES

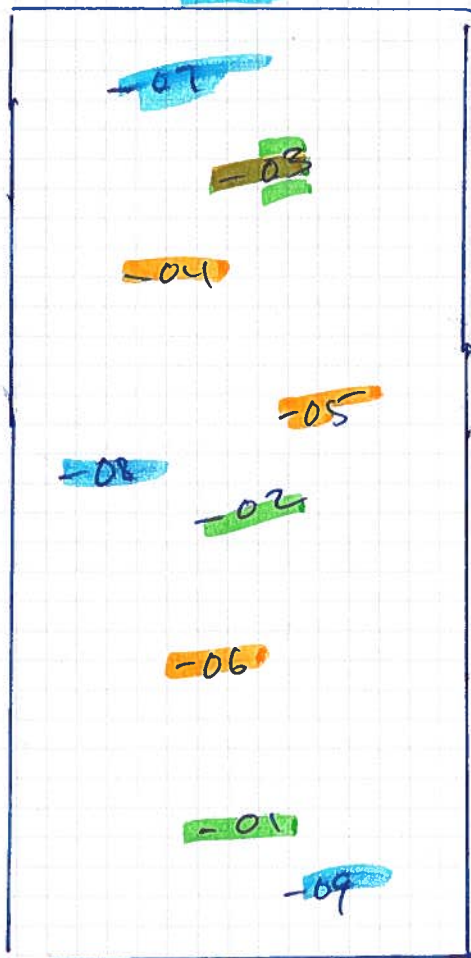
DESCRIPTION: Limited Asbestos Survey **Block 111**

Roof
Samples

Roof Penetration
Matrix

Roof
Felt
Paper

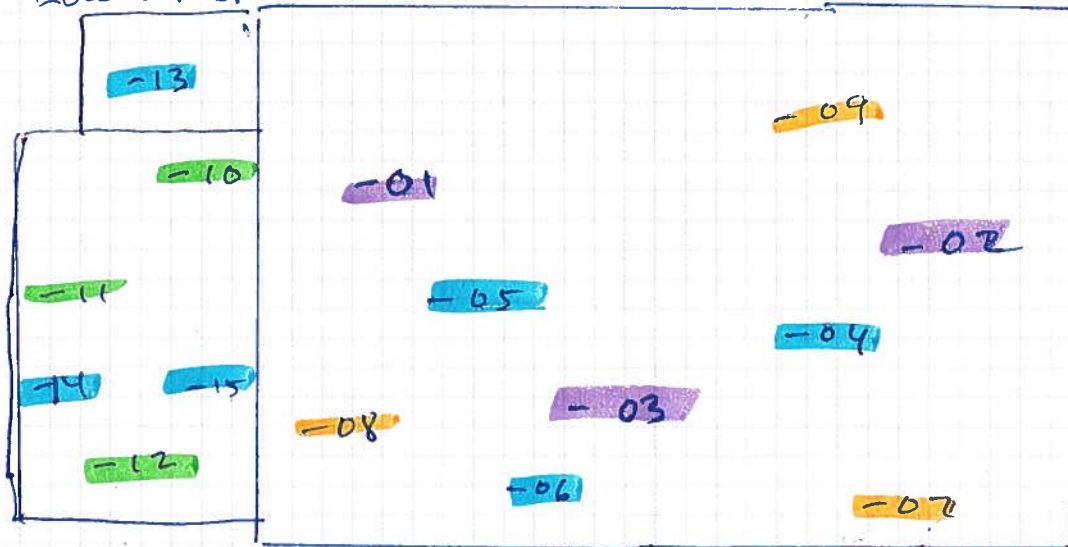
DESCRIPTION: Limited Asbestos Survey Bldg 102, 102 Lower Roof

Roof Shingles

Roof Penetration
Mastic

Roof Felt
Paper

Roll up
Roofing
